MICROSTRUCTURE ANALYSIS OF WELDING RESULTS RESISTANCE BUTT WELDING SPRING STEEL WIRE JIS G 3521

This research analyses the microstructure changes in JIS G 3521 spring steel wire welded using resistance butt welding. The results show significant changes in the weld zone and heat-affected zone (HAZ), including the formation of new phases and changes in grain size. These changes are correlated with mechanical properties such as hardness and tensile strength. This study aims to understand the influence of welding parameters on microstructure and mechanical properties, as well as contribute to the development of optimal welding techniques.

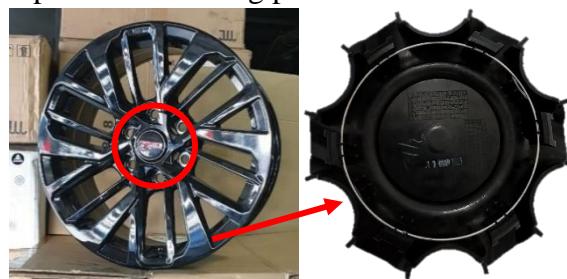
Figure 1.1 Wheel Holder Ornament

Wheel holder ornament is an important component in a car, which serves for aesthetics and structural safety. In the design of the Toyota Fortuner, this component is made of plastic that is attached to the wheel. To increase the strength and resistance to vibration and load, wire welding is performed. Previous research on optimising *resistance butt welding* on JIS G 3521 steel wire has been conducted, but the focus was more on mechanical properties such as tensile strength and optimal wire diameter. This research will analyse the microstructure of *resistance butt welding* on JIS G 3521 steel wire, because microstructure has a significant effect on the mechanical properties of the material.

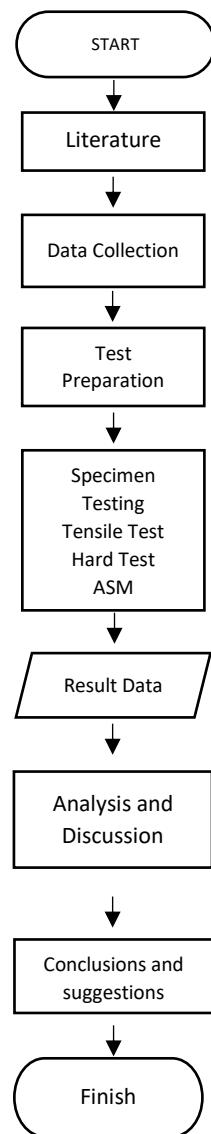
Figure 2.1 Flowchart

Literature Study At this stage, a review of relevant literature was conducted to obtain the theoretical basis and information related to the research topic. This literature study includes a review of journals, books, and other academic sources that discuss wire welding and microstructure testing. Tensile testing in order to determine how much the maximum tensile strength of the wire is after that conducting a test to determine the hardness of the welding results and then the Micro structure test, which is the process of testing the wire that has been welded in order to determine the mechanical properties of the wire structure.

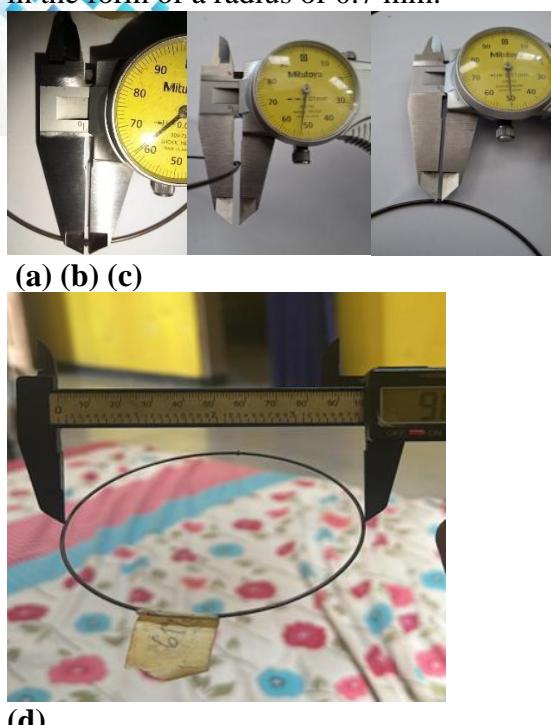
Figure 2.3 Measurement of Welding Results

Figure 2.3 illustrates the process of measuring welding results to determine the effect of variations in welding current and pressure on the characteristics of welded joints and evaluate the success of achieving specification standards. Figure 2.3(a) shows the melt thickness (TL) measurement, which determines the depth of melted material and the integrity of the joint. Figure 2.3(b) shows the melt diameter (DL) measurement, which is important for evaluating the fusion area and tensile strength of the joint. Figure 2.3(c) shows the tempering heating range measurement due to current variation, providing the extent of heat distribution that affects the mechanical properties and microstructure of the material. Figure 2.3(d) shows the measurement of specimen outer diameter $\varnothing 98.5$ mm (OD), which is important to ensure the dimensional conformity of the specimen in order to measure and evaluate the achievement of specification standards.

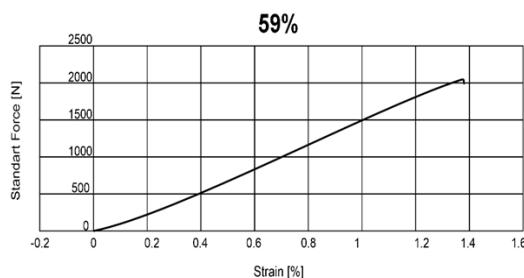
**Figure 3.2 59% Tensile Test Curve**

In the results of this Tensile testing at 59% current has the highest value of the 3 test samples with a value of F_{max} 2051 Newton with very hard and brittle properties because the test results are cut off in the welding results which means the results are brittle and not recommended for use on wheel holder ornament parts.

2. The acquisition of the value of the tensile strength test results in the 59% specimen of 2051 Newton has fracture characteristics (brittle and hard), the 60% specimen obtained a tensile strength result value of 1913 Newton characteristics (strong and tough). So that the 60% welding current variation has quite good specimen characteristics among the other 2 specimens. In the 61% specimen, the tensile strength result of 547 Newtons has a fracture characteristic (brittle) because this specimen breaks up in the welding results. So from this, the welding result that is quite good is the 60% variation because it has quite good values and characteristics between the 59% and 61% specimens.

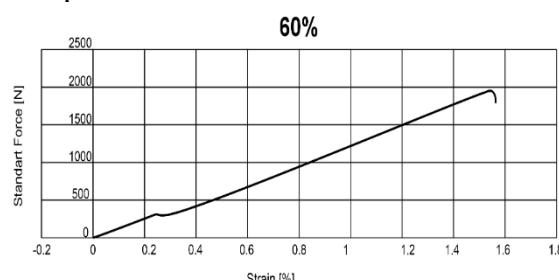
**Figure 3.3 60% Tensile Test Curve**

The tensile test results at 60% current have a high enough value of F_{max} 1913 Newton, therefore this 60% current has material properties that are quite hard and ductile, it appears that the wire has good ductility. This is indicated by the neck (*necking*) on the wire specimen after testing. This neck is formed due to the plastic deformation experienced by the wire before fracture. The wire has an initial diameter of 1.4 mm and a final diameter of 1.30 mm. This shows that the wire experienced a diameter reduction of 0.1mm during the test. This diameter reduction is indicative of the plastic deformation that the wire underwent.

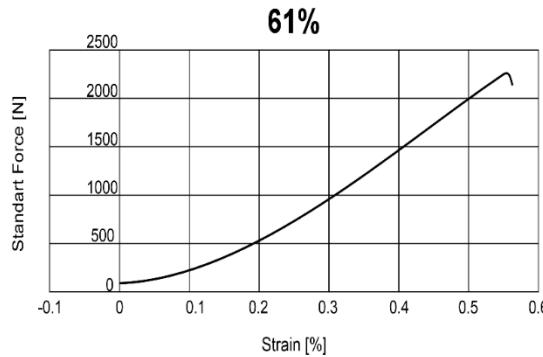
Figure 3.4 61% Tensile Test Curve

The results of the tensile test at a current of 61%, namely F_{max} 547 Newton with these results the tensile strength value is very low among the 3 samples tested. Welding including optimal welding. shows that this test specimen has *failed* the welding process, resulting in a

fracture at the melting point of the welding material, has a strength below the average and below the *tensile* strength of the material itself, caused by a combination of sufficient current with too little pressure, so that the material that should get welding does not experience sufficient melting.

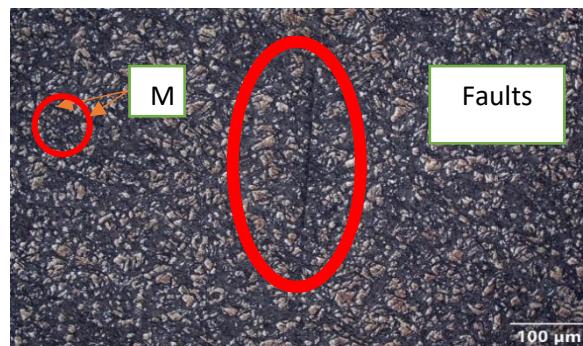
Figure 3.5 Microstructure Analysis of 59% (1)

The 59% welding result does not experience more heating during welding. because there is still a gap that is not melted properly when heating takes place in the welding process. As well as having hard and brittle properties that cause fractures between the two welding joints when in the Tensile test.

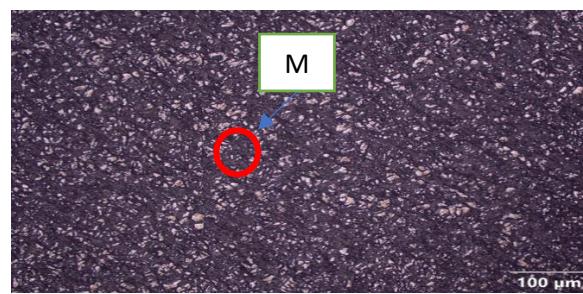
Figure 3.6 Microstructure Analysis of 59% (2)

The results of microstructure testing at a current of 59% welding results at this current have a fairly good level of melting because there are no gaps that are not welded to these results the properties listed in Figure 4.5 are martensite properties which have a fairly hard and ductile strength and welding results 59% is the optimal welding result.

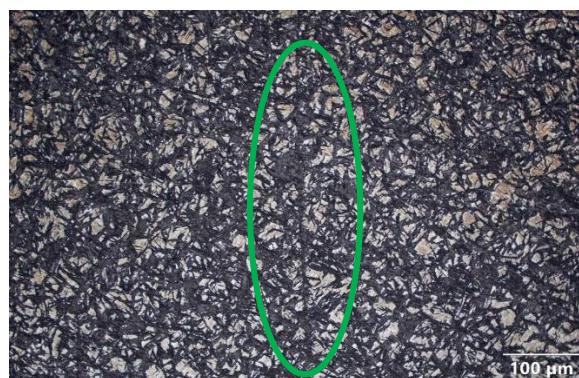
Figure 3.7 Microstructure Analysis 59 (3)

The green circle shows that the microstructure of the welding result contains martensite properties which has a hardness value of 409 HV. However, the 59% welding results are unevenly melted because there are still gaps that do not experience optimal melting from the welding and have hard, brittle properties and have carbon content > 0.5% which causes a fracture between the two welds when tested Pull.

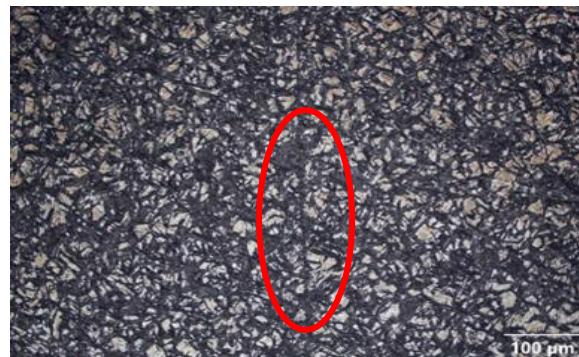
**Figure 3.8** Microstructure Analysis of 60% (1)

At this magnification, the microstructure of the 60% welding results is martensite which has a fairly good hardness and strength value, but sample 1 has a fault line in the middle of the surface due to poor penetration during welding.

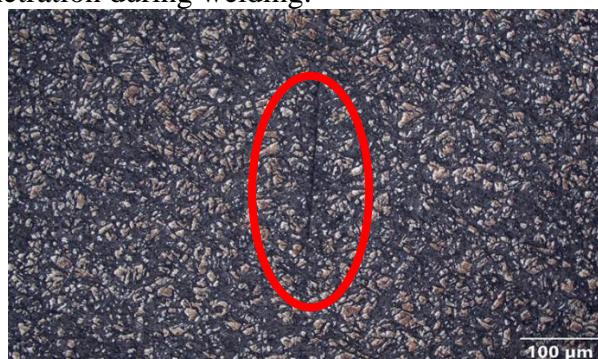
**Figure 3.8** Microstructure Analysis of 60% (2)

In the results of the 2nd sample of 60% welding results, there is a fairly deep crack in the middle area due to lack of heating when welding takes place and due to the rate.

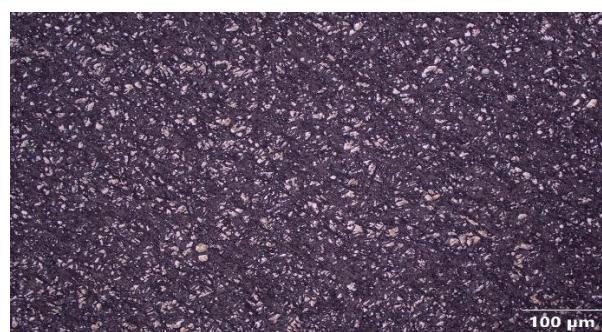
**Figure 3.9** Microstructure Analysis 60 (3)

In this 3rd sample in the welding results that this result is quite better than the previous sample because in this result in the welding process the penetration is quite good, so in this result there are no fractures or cracks on the surface of the welding result.

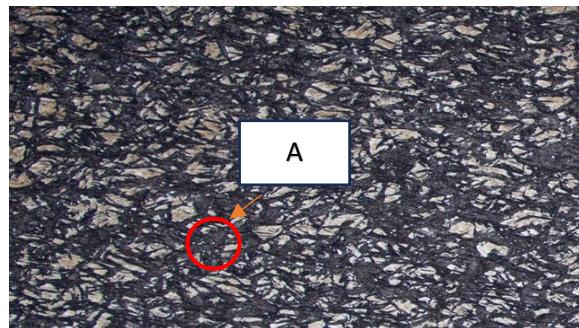
**Figure 3.10** Microstructure Analysis of 61% (1)

In this sample, it is stated that the results are very good because there are no breaks or scratches in the welding results, so the penetration in this welding can be said to be better than the previous sample.

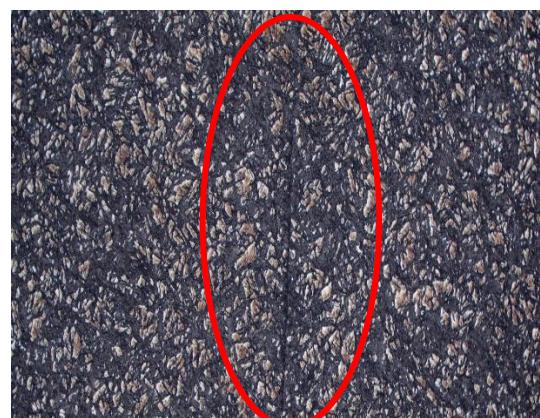
**Figure 3.11** Microstructure Analysis of 61% (2)

In this sample, there are significant changes caused by excessive heat which causes heating penetration when welding quite well and has a long enough fracture in this sample so that the results of the 2nd sample do not meet the

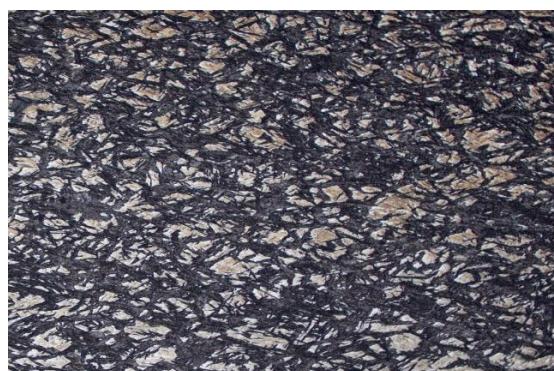
**Figure 3.12** Microstructure Analysis of 61% (3)

In this sample is a very good result than the previous sample because this sample experienced good penetration with a high heating value so that this result is the best of this largest current.
